FINAL REPORT
INTERMEDIATE WATER RECOVERY SYSTEM
CONTRACT NAS 9-11996

72-8901, Rev. 1

12 April 1973

The Intermediate Water Recovery System (IWRS) is intended to be used for the collection, storage, and processing of urine, wash water, and humidity condensate from a crew of three aboard a spacecraft. Potable product water extracted from these three waste-water sources can be stored in the IWRS tanks or returned directly to the spacecraft water supply. The IWRS is automatically operated and is instrumented for continuous monitoring.

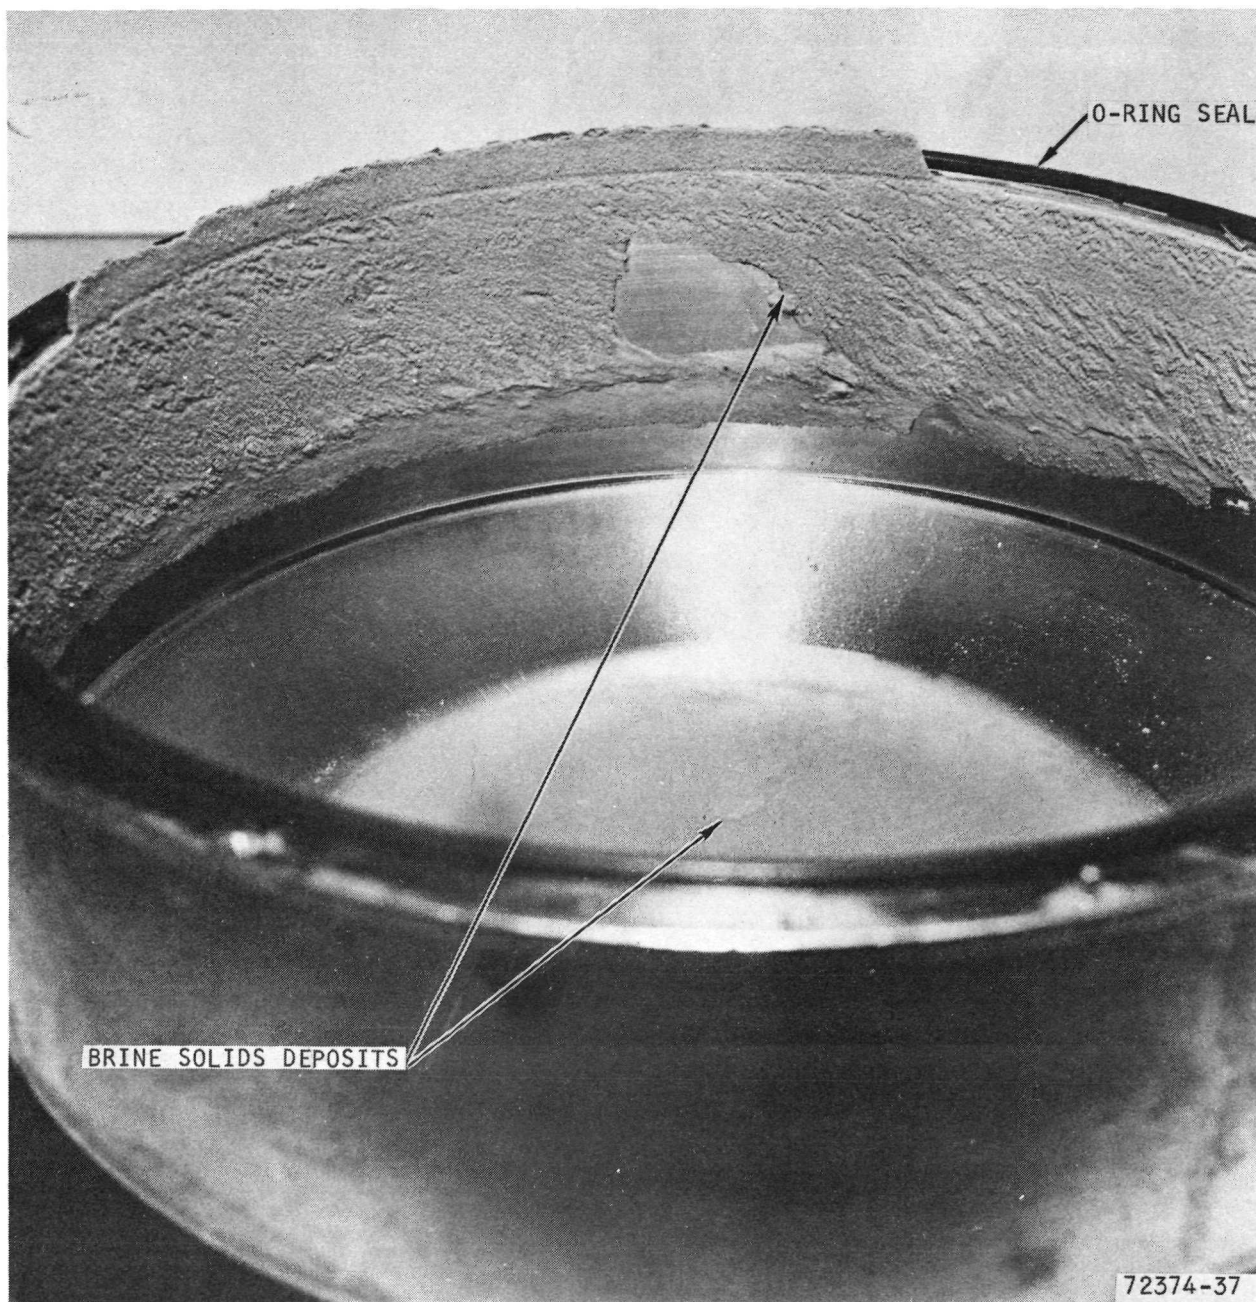
Figure 3-35. Phase Separator--Disassembled

The disassembled phase separator is shown in Figure 3-35. Detail parts are shown in Figures 3-36 through 3-42. Upon disassembly, approximately 10 cc of urine brine was found on the bottom plate of the outer bowl; no brine was found on the outside of the inner bowl. The magnetic coupling cover was moist and smelled of urine.
